"Cam-On" Fuel Fill Cap Failures During Smog Check

HONDA ServiceNews

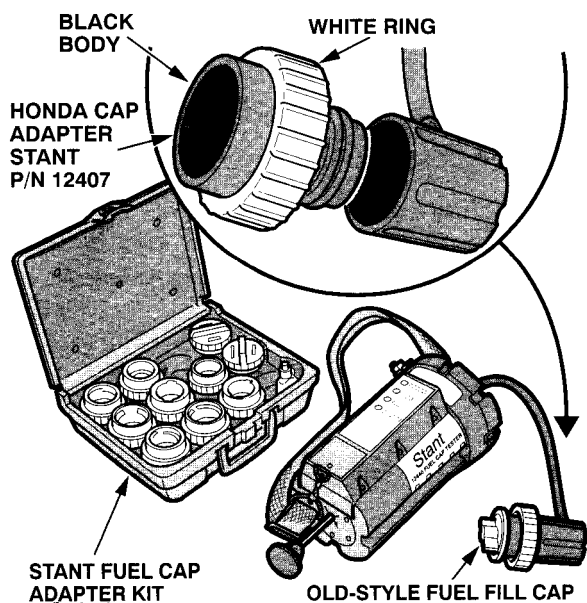
The problem might not be the fuel fill cap, but instead the equipment used for testing. If the smog check station is using a Stant fuel cap adapter kit, and the wrong adapter is used, the fuel fill cap *won't* fit properly, and it *will* fail the leak test.

The right adapter for testing these fuel fill caps is Stant P/N 12407 (it's black with a white ring). If your dealership is a state-certified smog check station, and you're *not* using this adapter, contact Stant Corporation at **765-825-3121** and order the adapter. If customers coming into your dealership failed the test at other smog check stations, as a customer courtesy, contact those stations, and tell them about this adapter.

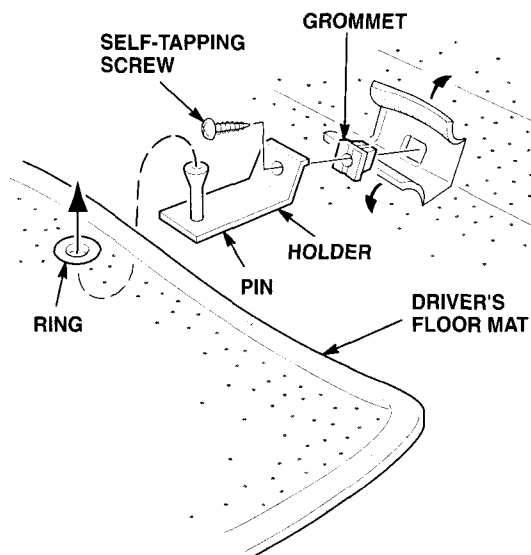
Driver's Floor Mat Installation: '99-01 Civic

On '99-01 Civics, when installing the driver's floor mat, make sure you install the floor mat holder and attach the floor mat to it. Earlier Civic models used rubber nibs to hold the floor mats in place. To install the floor mat on '99-01 Civics, just install the holder to the floor with the grommet and self-tapping screw, and slip the ring on the end of the mat over the pin.
